Redcliff Battery

Type Coast Defence Battery

Victorian Forts Portsmouth 42

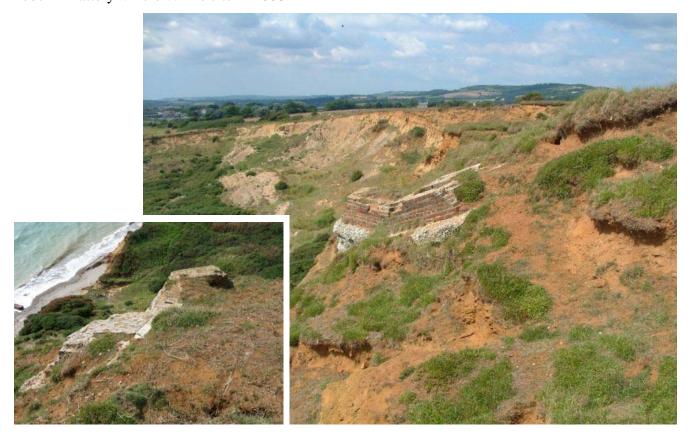
In 2008 a few vestiges of the concrete gun positions were visible in the collapsing cliff.

Redcliff Battery: Below: The site in 2008

By 1891 Redcliff was being slowly eroded by the collapsing cliff and it was decided to abandon it. The landward ditch was filled and all structures demolished.
