Redcliff Battery

History and Description

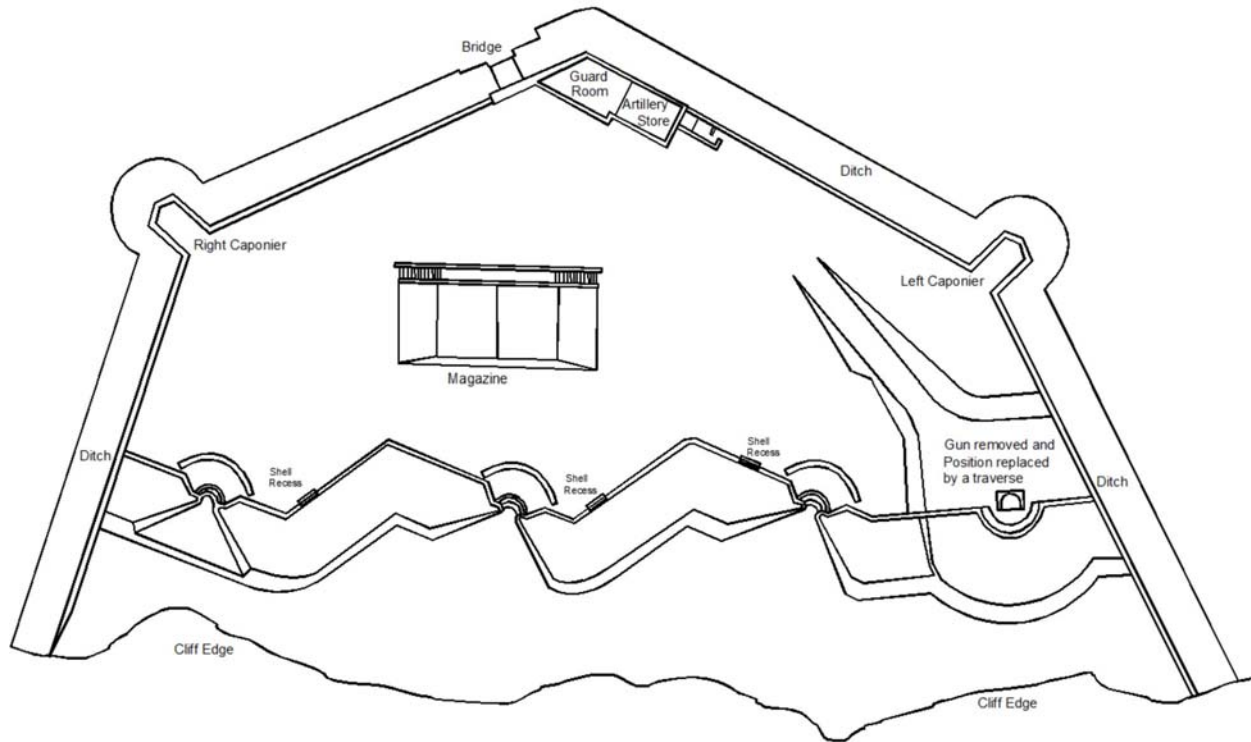
Redcliff Battery

This battery was built close to the edge of a cliff to the west of Culver Cliff, about 1,000 yards to the east of Yaverland Battery and 150ft. above the sea. Problems with slippage were evident right from the start. Its original armament was four 7-inch R,B.L. guns. The four guns faced seawards and behind no.2 gun was the main magazine for 190 barrels of powder. Beside the first three guns were shell recesses. A ditch and Carnot wall surrounded the battery and reached to the cliff edge on either side. Two musketry caponiers covered both ditch and the line of the Carnot wall. The entrance to the battery was on the north west side over a drawbridge and immediately inside was a single building which contained guardroom and an artillery store. Its purpose was to assist Yaverland and Sandown Fort in preventing a landing in Sandown Bay. On the left flank part of the cliff began to give way in 1867 and in 1868 it fell into the sea. In 1887 it was decided to remove one 64pr. from the the left flank of the battery, no 4 gun, and to construct a traverse instead to prevent ships from enfilading the battery from the Culver Cliff area. The remaining 64prs. were to be blocked up on 6ft. parapet slides.

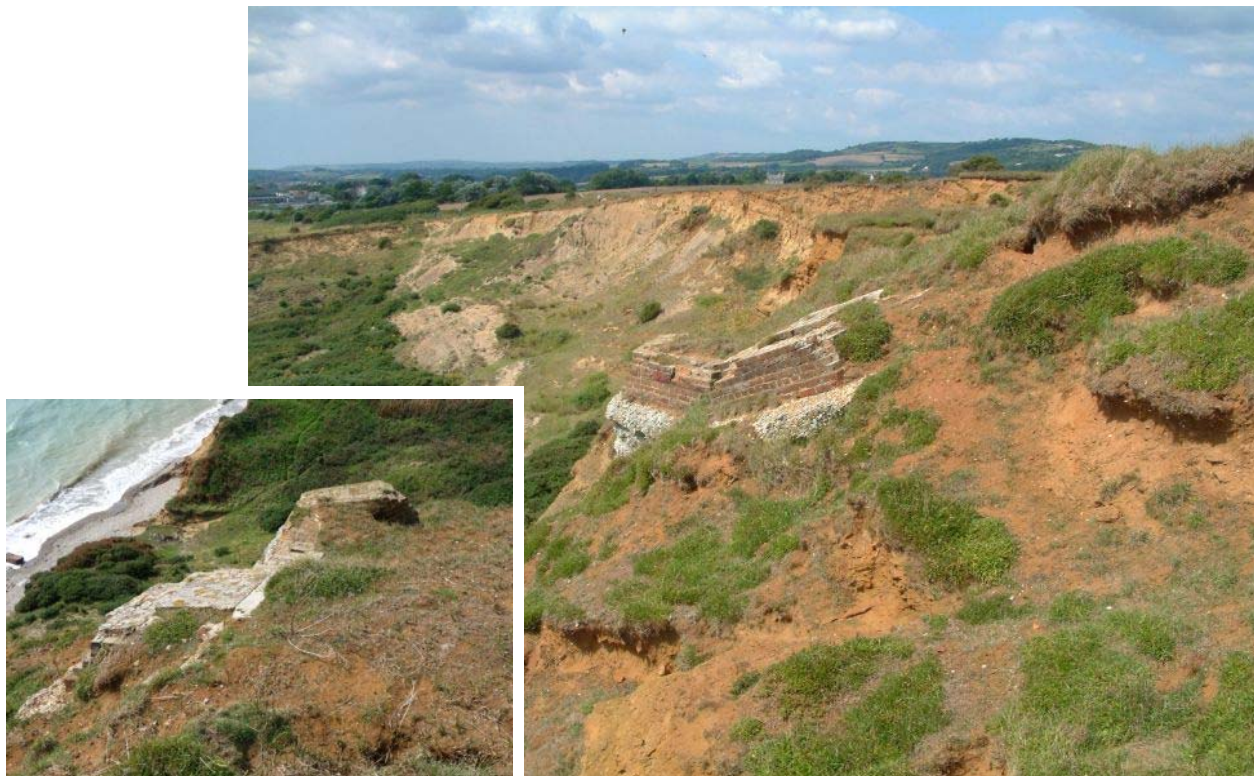
In 2008 a few vestiges of the concrete gun positions were visible in the collapsing cliff.

Redcliff Battery : Below: The site in 2008

By 1891 Redcliff was being slowly eroded by the collapsing cliff and it was decided to abandon it. The landward ditch was filled and all structures demolished.
